Manhole Inspection Summary

Manhole # S37E__043MH

Inspection ☐ Is Incomplete Rating: **5) Immediate Attention Required**

Location Address: **101 e lexington st**

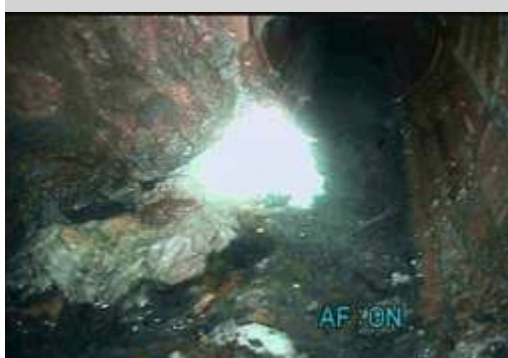
Misc. Channel Debris

channel debris

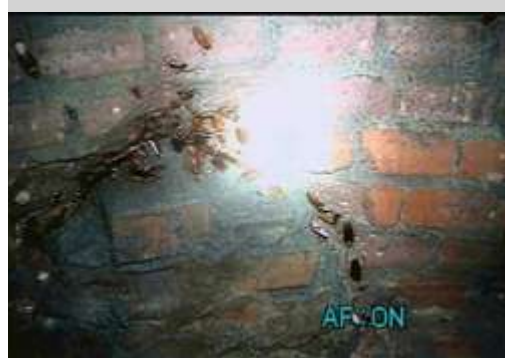
Defect 7

Condition: ☐ Sound ☐ Cracked ☐ Root Intrusion ☒ **Loose Brick** ☐ Deteriorated

hole in barrel wall (loose bricks)

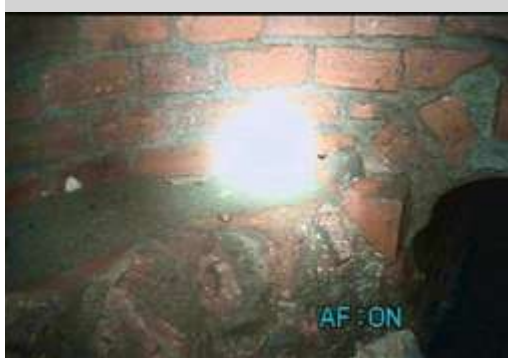
Defect 6

Condition: ☐ Sound ☒ **Cracked** ☐ Root Intrusion ☒ **Deteriorated** ☐ Leaks ☐ Debris

bench cracked and deteriorated

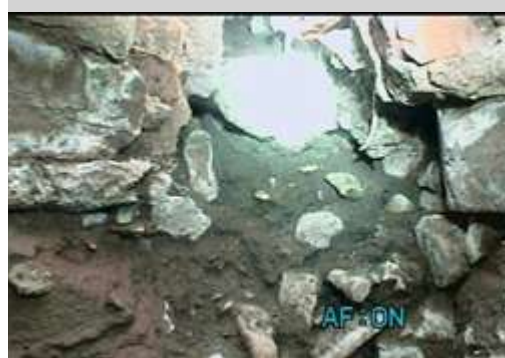
Defect 4

Condition: ☐ Sound ☒ **Cracked** ☐ Root Intrusion ☒ **Loose Brick** ☐ Deteriorated

corbel cracked, loose bricks

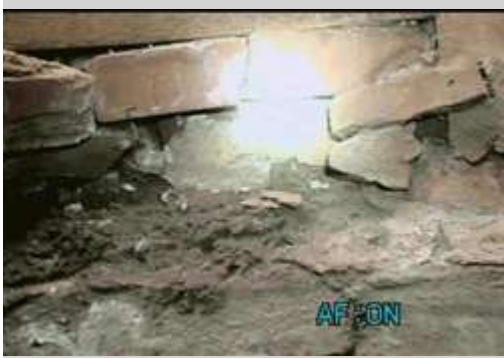
Defect 3

Condition: ☐ Sound ☒ **Cracked** ☐ Root Intrusion ☒ **Loose Brick** ☒ **Deteriorated**

frame adj; chimney cracked, loose bricks, deteriorated

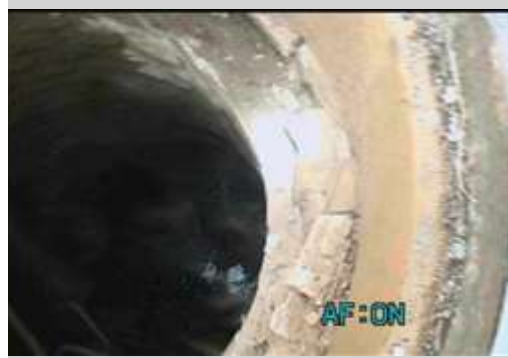
Defect 2

Offset: **2** (in.)

Condition: ☐ Sound ☒ **Cracked** ☐ Leaks

offset

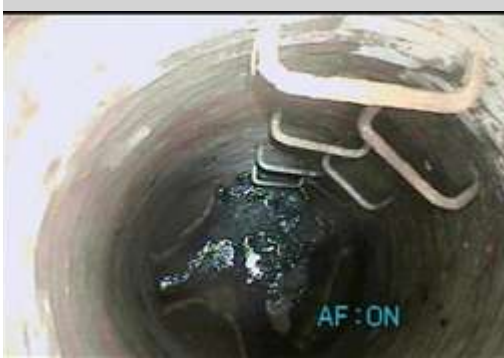
Defect 1

Count: **7** Missing: **0** ☒ **Corroded**

corroded steps
